Starfire Team Final Report, Jun 3, 2003

This Appendix contains NSTS-37379 Starfire Team Final Report in Support of the Columbia Accident Investigation, 3 June 2003.

Starfire Team Final Report

in support of the *Columbia* Accident Investigation

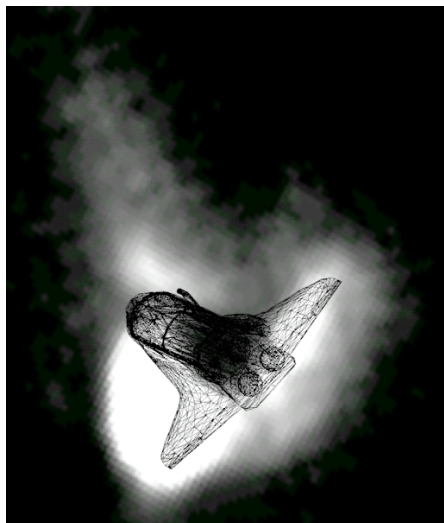
Fig. 6A: Flare 1. NASA image JSC2003e03395. The second digital still analyzed was taken at about the same time as the right-hand image in Figure 6. The still is shown here after a blind deconvolution has been applied to the image and its contrast enhanced. It has been properly oriented and displays a wireframe overlay of the orbiter. The wireframe overlay has been approximately scaled. Exact placement relative to the image is unknown. See Appendix D for more details regarding these images and others. The flare image and the digital still are considered to represent an off-nominal condition, and all five AOS listed in the paragraph above Fig. 6 are considered off nominal.

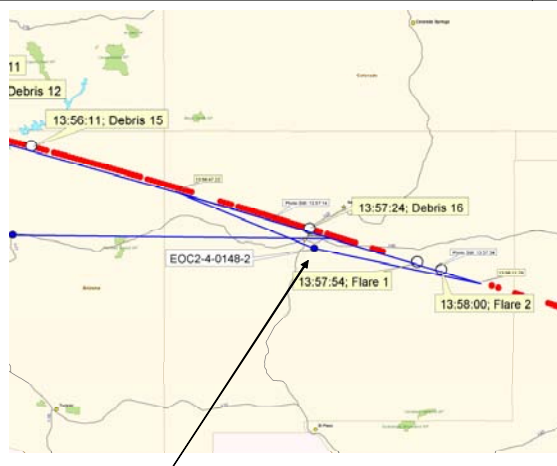
Starfire Optical Range Location

Location: Kirtland Airforce Base, NM
GMT coverage for the 5 deg fov: 13:56:47.22 – 13:58:11.29 (+/- 2 secs)

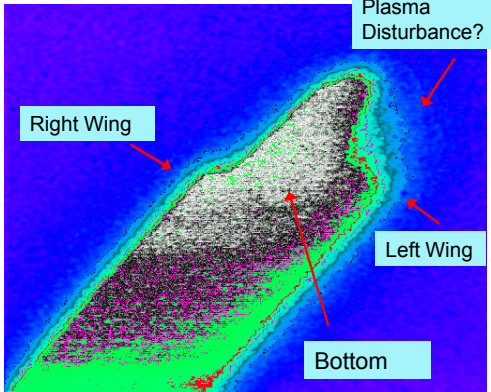
- Colors represent pixel values No processing was performed other than the intensity highlighting
- Left wing chine and glove are not visible at this viewing angle
- Apparent disturbance seen in leading plasma
- Indeterminate significance at this time
- No nominal shuttle re-entry images exist for comparison

Image has been cropped and pixel intensity modified to bring out detail

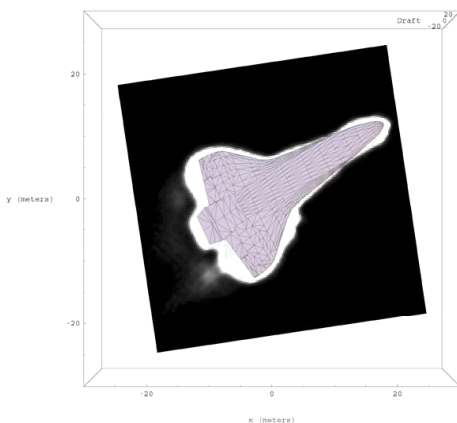
Starfire Optical Range Image (26 March 2003)
model overlay (R. Cies, R. Fugate, R. Johnson)
image sharpened using deconvolution (J. Christou)
The model scaling and orientation are based on telemetry (altitude, longitude, and latitude from NASA) and observations (azimuth, elevation, and range from SOR). The image scaling and orientation were derived from measurements using star fields. The Columbia model was provided by NASA.

Mathematically scaled wireframe model overlay on re-processed image

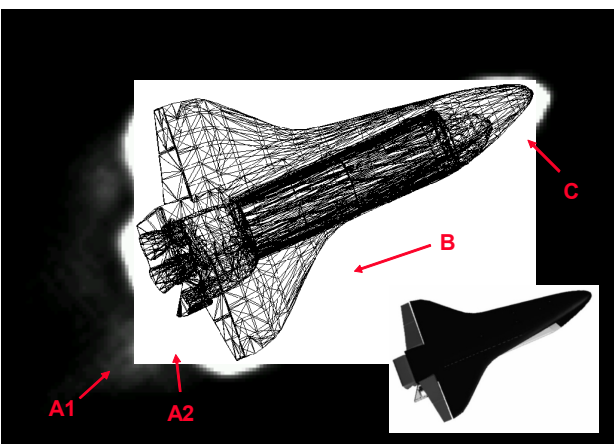
3 Areas of Interest

- Asymmetric (A) Gas Flow Pattern
 - Left wing more elongated in vertical wake (A1)
 - Greater area brightened in aft wing area (A2)
- Asymmetry (B) of Wing (Left vs. Right)
 - Convex in region (Xo-1100, Yo-256), leading edge of left wing.
- Asymmetry (C) of Nose

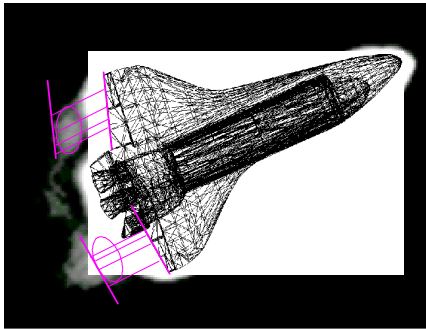
- Gas (elliptical circles) seen behind right wing
 - Assumed nominal
 - Assumed symmetric w/respect to left wing

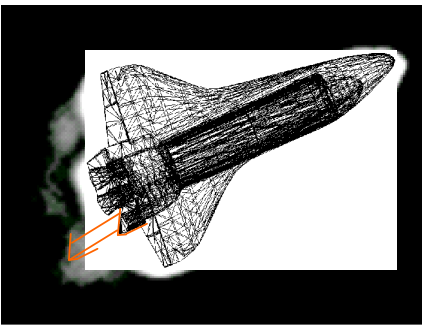
- Gas flow from the tail identified

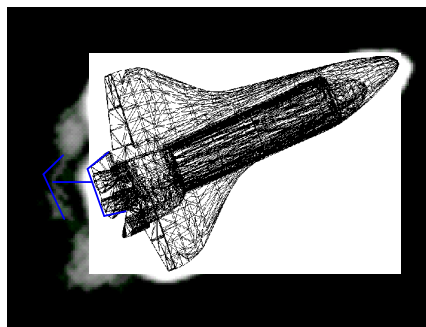
- Gas flow from the body flap identified

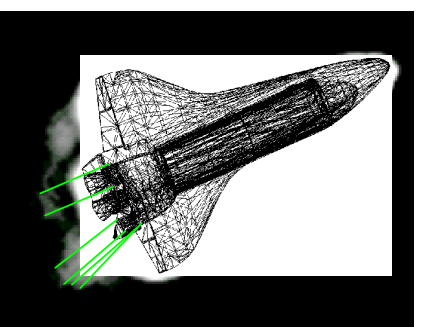
- Gas flow from the OMS pods suggested as explanation
- See next page for additional options

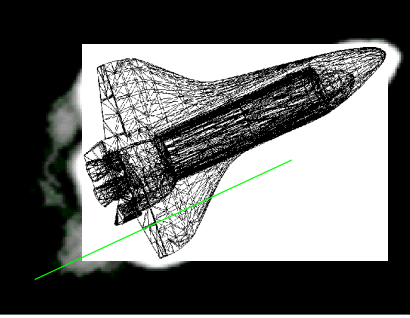
- Flow from split between inboard and outboard elevons?
 - Symmetry expected but not seen
 - Unlikely
- Elevon position
 - Right and left elevons are between 0.3 and 0.7 degrees different in position between 13:57:14.0 – 13:57:14.99
 - Unlikely but could contribute
- “Bulges” in leading edge create turbulence and/or hot gas
 - This possibility cannot be ruled out
 - Potential resultant gas flow should be modeled
- Viewing geometry and refraction could contribute

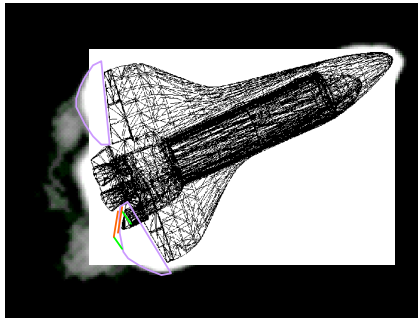
Greater area is brighter behind trailing edge of left wing (A2)

- Both wings show a gas flow pattern that is rounded; however, left wing has an additional bulge in area near elevon gap
- This brightened zone appears to correlate with the tail and left OMS pod/stinger
- Some contribution could be from either the elevon, or from the "bulges" along the leading edge of the wing

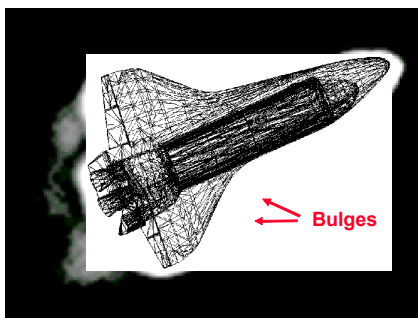
Two Bulges on Wing (B)

- Clearly outboard of wing-structure
- Shape is inconsistent with wing leading edge
- Inconsistent with flow pattern on right wing

- Tile damage?
 - Possible, but unlikely to change bow shock and wing shock shape (per aerothermo team)
- Damage to wing leading edge?
 - Could change local bow shock and wing shock shape (per aerothermo team)
- Viewing geometry and refraction could contribute

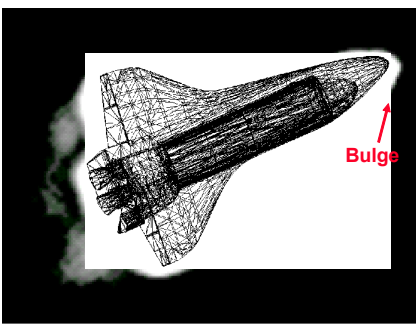
Asymmetry of Nose (C)

- Unknown if nominal
- Localized intensity increase
- Could be normal canopy shock seen from this angle
- Viewing geometry could hide symmetry

- **Asymmetric gas behind left wing (A1)/brightened aft region(A2)**
 - Can be accounted for with structure of Orbiter
 - Contribution from leading edge "bulges" can not be ruled out
 - Contribution from elevon can not be ruled out
- **Bulges (B)**
 - Caused by either local increase in intensity or anomalous gas flow
 - Some possible causes of anomalous gas flow presented
 - » Modeling and wind tunnel testing investigations should aid in understanding and/or generate new theories
 - » Some measurements of angles of bulges in relation to orbiter may be possible if so requested by other teams
- **Nose asymmetry (C)**
 - Likely nominal condition
 - Flight data (OI and OEX) show no anomalous readings at the chin panel or vent nozzles at this time

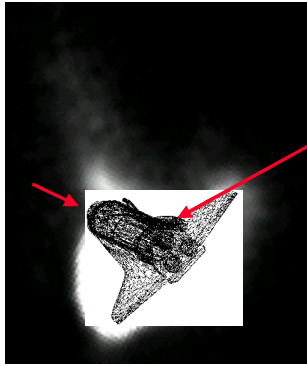
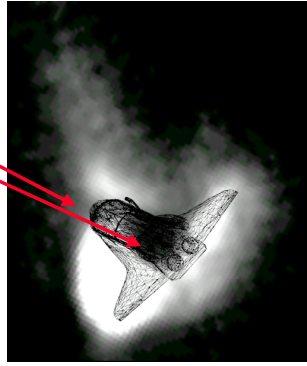
Re-processed

Faint pixels enhanced

Shadowing due to relative location of sun

- The left wing has increased intensity
- The nose/tail has increased intensity
- Improved resolution (vs. video frames) suggests
 - An event in the left wing generates a flow field that, at this visual aspect, appears to intersect with the tail
 - Flow field is generally too faint to see but when additive with nose/tail brightness, appears to cause an overall brightening of the nose/ tail region
 - An illumination of the wing illuminates area(s) previously in shadow (nose or tail)
 - There are no overt indications in information from the orbiter that suggests the tail underwent any change at this moment in time
